RE: March 7 and March 9, 2016 Clean Water Act Inspections

Please find enclosed the National Pollution Discharge Elimination System (NPDES) inspection reports for the U.S. Environmental Protection Agency's (EPA) March 7, 2016, and March 9, 2016 inspections of Platform Hillhouse and Platform A.

**Region 9 Enforcement Division
75 Hawthorne Street
San Francisco, CA 94105
INSPECTION REPORT**

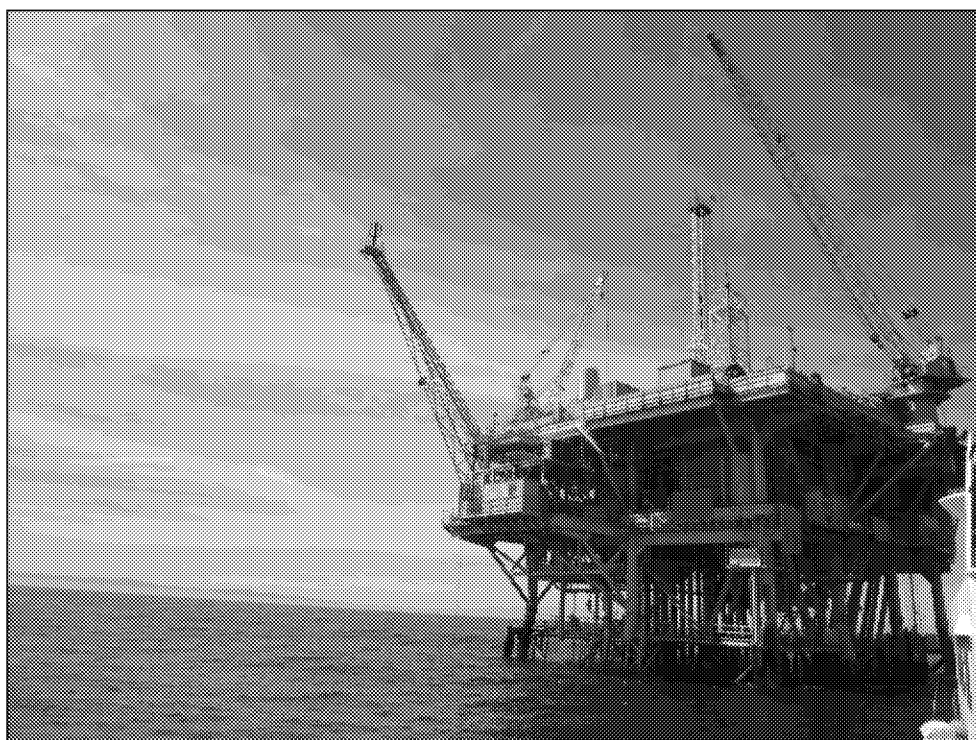
Photograph 1. View of DCOR, LLC's offshore Platform A.

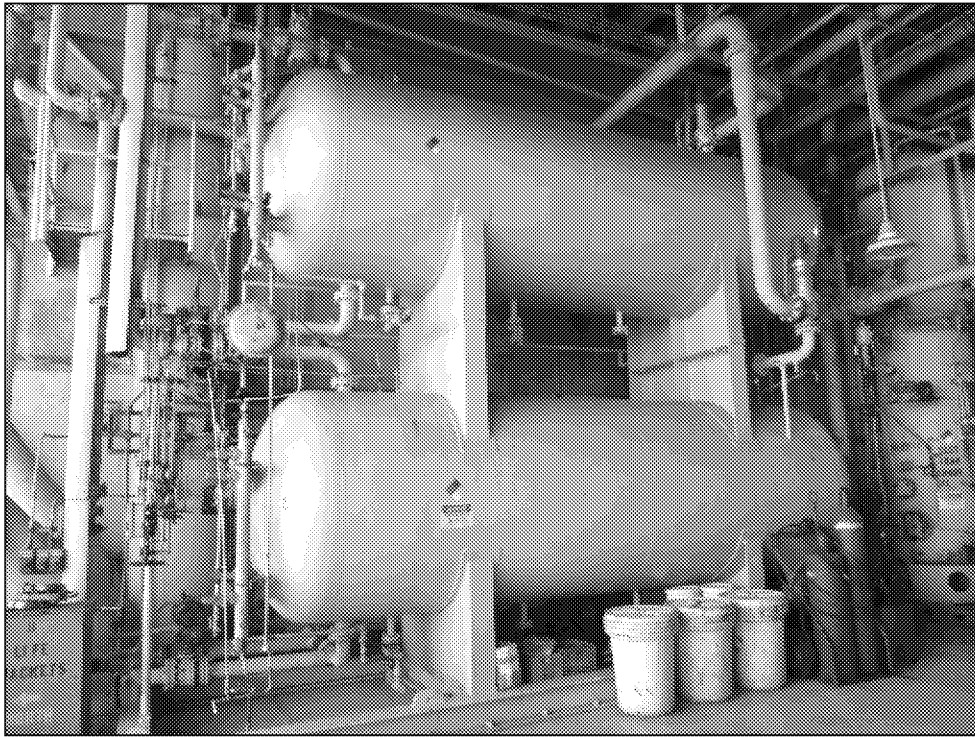
Photograph 3. View of gross oil separators #1 and #2.

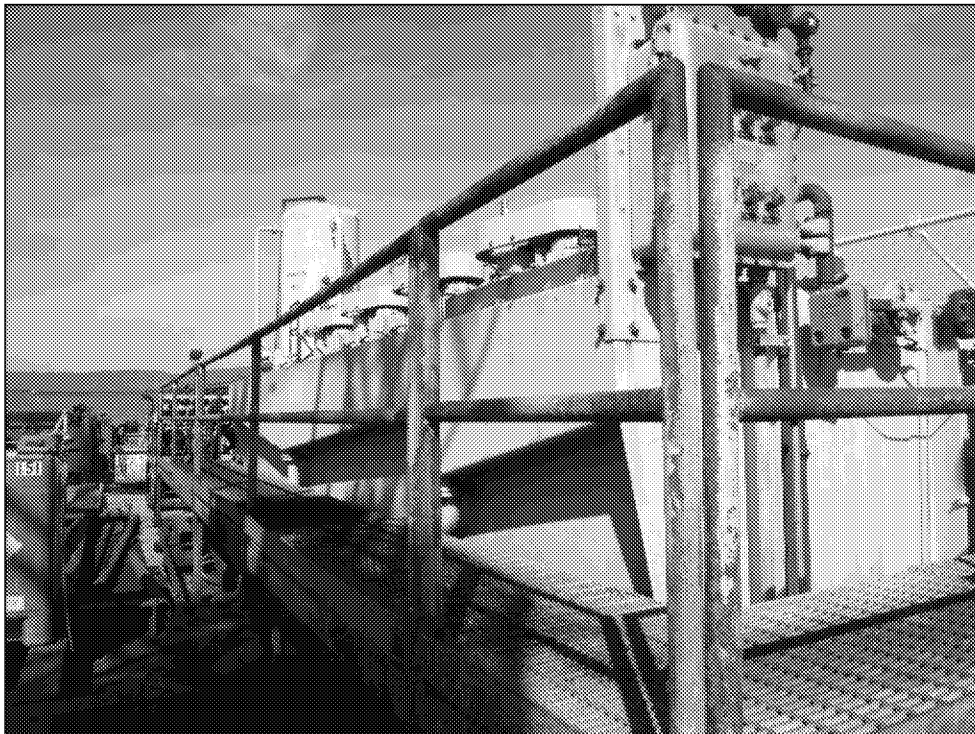
Photograph 4. View of WEMCO oil water separator at the platform.

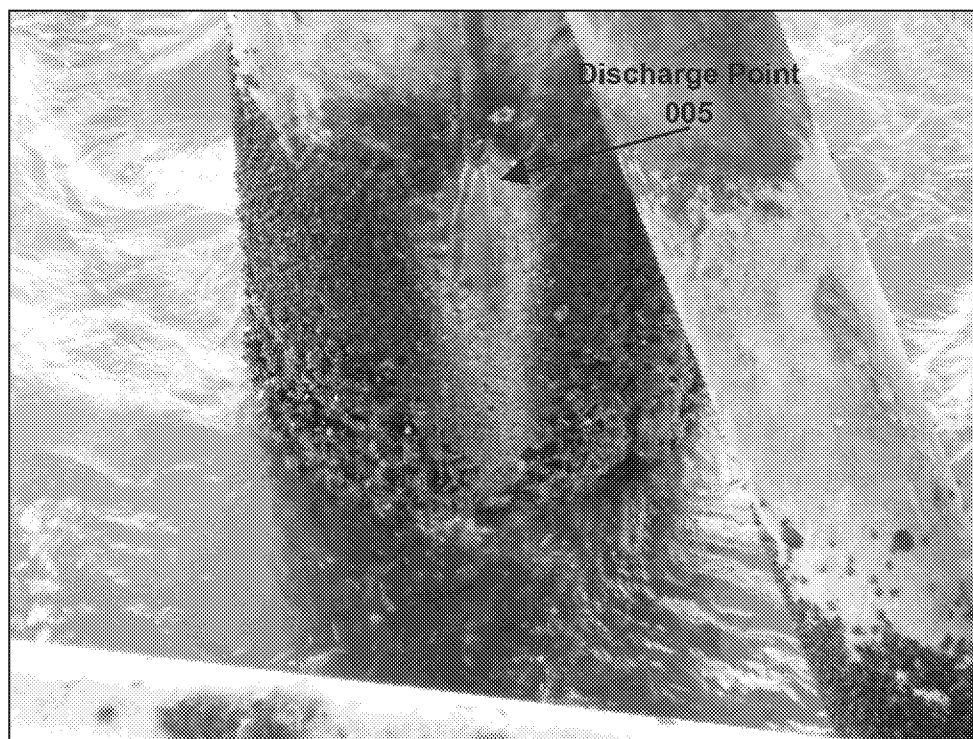
We observed the Facility redFox® MSD used to treat sanitary (black water) wastes (Discharge 005) prior to being discharged to the Pacific Ocean (Discharge 005) (refer to Photographs 5 and 6). The redFox® MSD unit was stamped with a manufacture date of June 29, 2009.

Photograph 6. View of actively flowing sanitary waste discharge point (Discharge 005) to the Pacific Ocean.

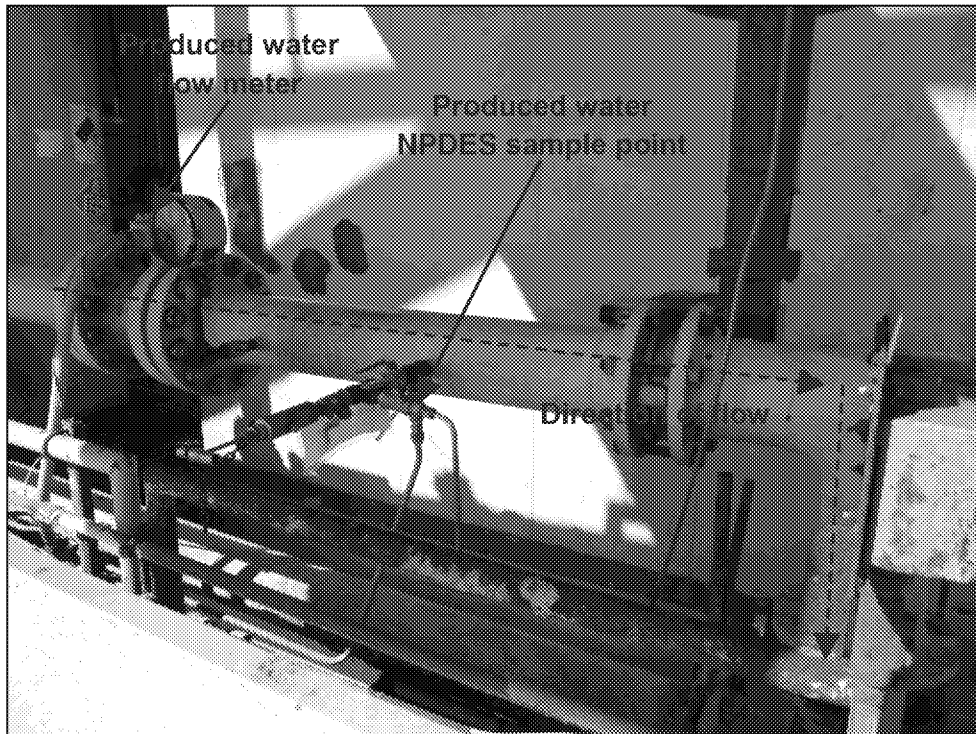
During the Facility walk through, we observed the Facility produced water treatment train. The Discharger's produced water (Discharge 002) NPDES sampling point is located at the discharge pipe off of the WEMCO. We viewed this discharge pipe as a component of the inspection (refer to Photographs 10, 11, and 12). Based on our observations during the inspection, the produced water NPDES oil and grease sample location appeared to provide representative samples; however, we observed a bypass line around the NPDES sample point during the inspection (refer to Photographs 13 and 14). We observed that the produced water NPDES sample point bypass piping was not in operation during the inspection, as indicated by the closed valve (refer to Photograph 14). The receiving water (Pacific Ocean) within the vicinity of the produced water discharge pipe was viewed and observed to be free of visually objectionable characteristics at the time of the inspection (refer to Photograph 15).

Photograph 10. View of produced water (Discharge 002) NPDES sampling point located off of the discharge pipe from the WEMCO with the produced water flow meter.

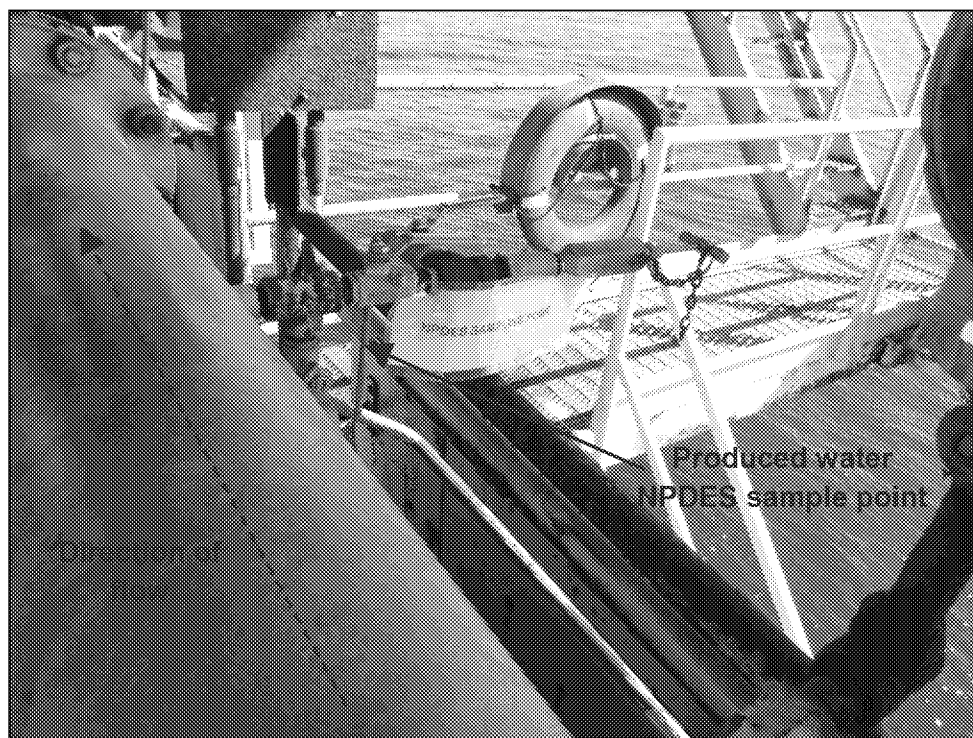
Photograph 11. Alternate view of produced water (Discharge 002) NPDES sampling point located off of the discharge pipe from the WEMCO.

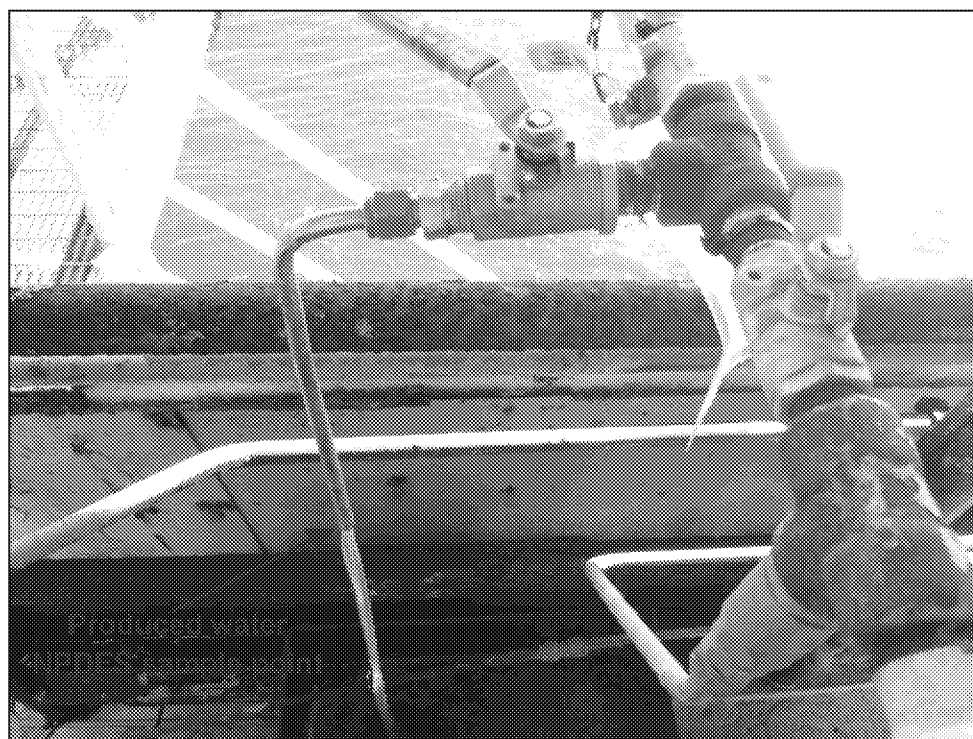
Photograph 12. Close-up view of the produced water NPDES sampling point, shown in Photographs 10 and 11.

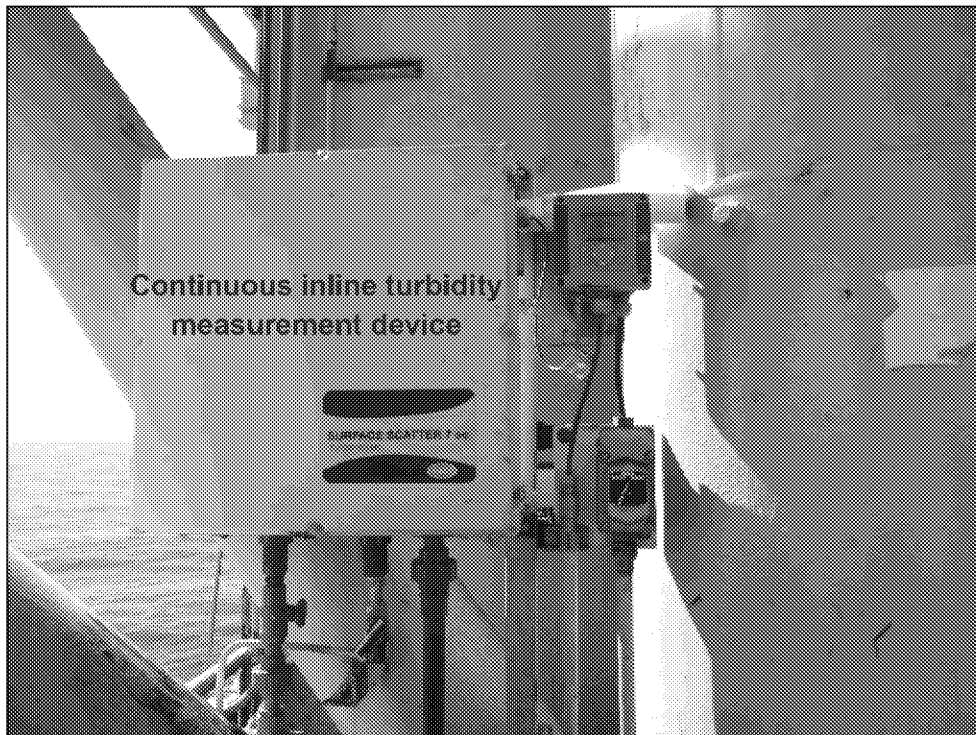
We observed the Facility's on-line oil and grease monitor, which was installed in accordance with Part II.G.6, On-Line Oil and Grease Monitors, requirements of the Permit. The Discharger conducts additional internal process monitoring for oil and grease in produced water after the WEMCO on the discharge pipe via continuous inline turbidity measurement utilizing a HACH Surface Scatter® 7 sc turbidimeter (refer to Photographs 14 and 16). At the time of the inspection, we observed the continuous inline turbidity measurement of produced water to be 2.58 nephelometric turbidity units (NTUs). The Facility representatives stated that there is an alarm (visual and audible) that activates when the inline turbidity monitor exceeds 15 NTU and 20 NTU. The Facility representatives stated that these set points were to ensure the produced water (Discharge 002) did not exceed the monthly average and daily maximum oil and grease Permit effluent limits of 29 mg/L and 42 mg/L, respectively. The Facility representatives said the set points were developed based on facility-specific correlation between the turbidity monitor and oil and grease measurements.

Photograph 16. Close-up view of continuous inline turbidity measurement device (shown in Photograph 14), a HACH Surface Scatter® 7 sc turbidimeter, used to comply with Part II.G.6 On-Line Oil and Grease Monitors of the Permit.

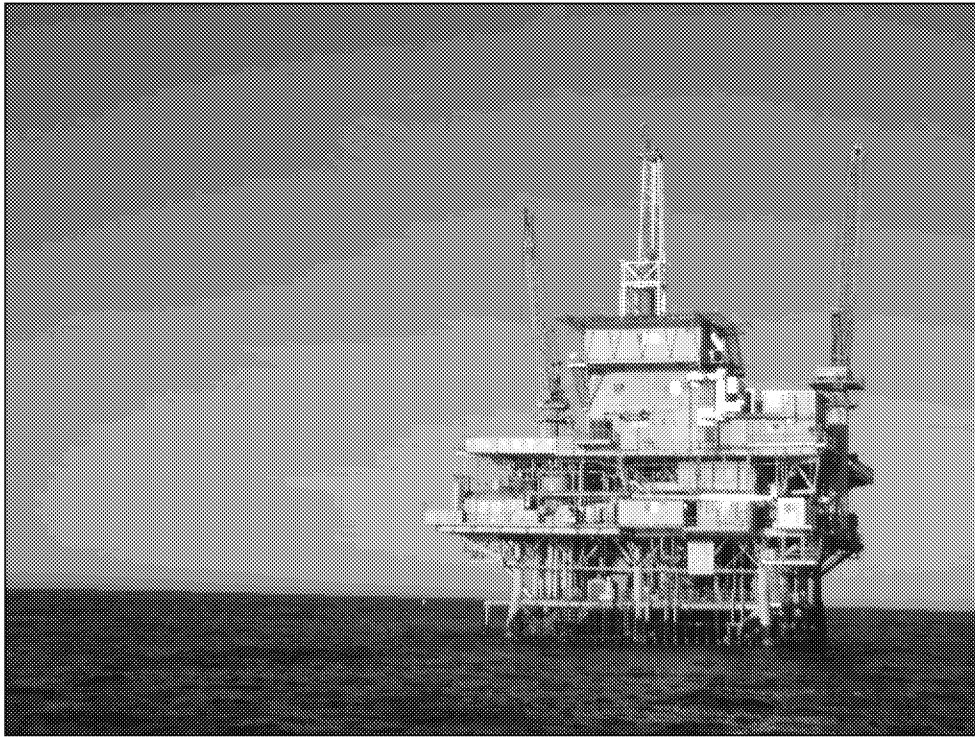
Photograph 1. View of DCOR, LLC's offshore Platform Hillhouse.

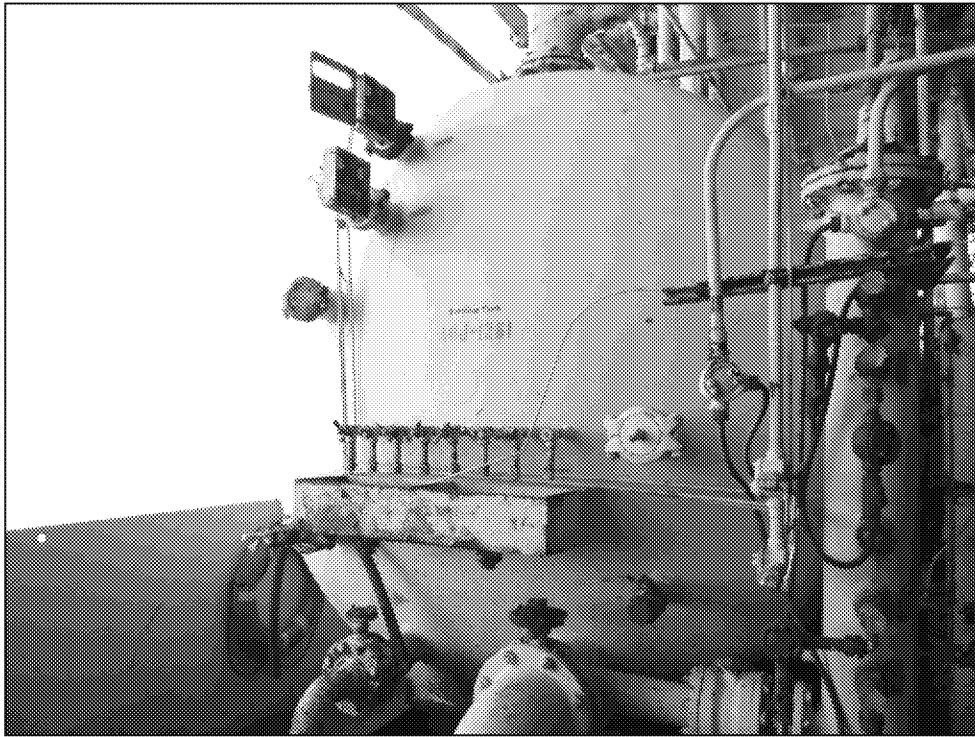
Photograph 3. View of old Platform Henry oil treater tank located on the production deck of the Facility. This tank has been repurposed and is now known as the settling tank and receives deck drainage and fire control system water from the sump tank/vessel prior to being commingled with produced water at the WEMCOs.

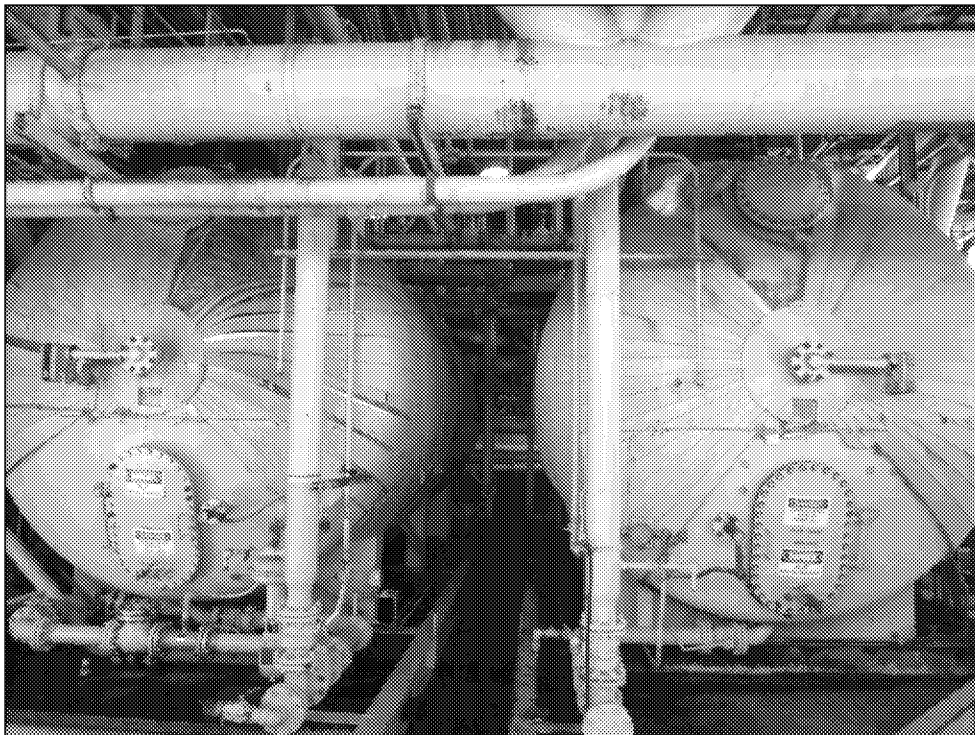
Photograph 4. View of two heater treaters (North and South) located on the production deck.

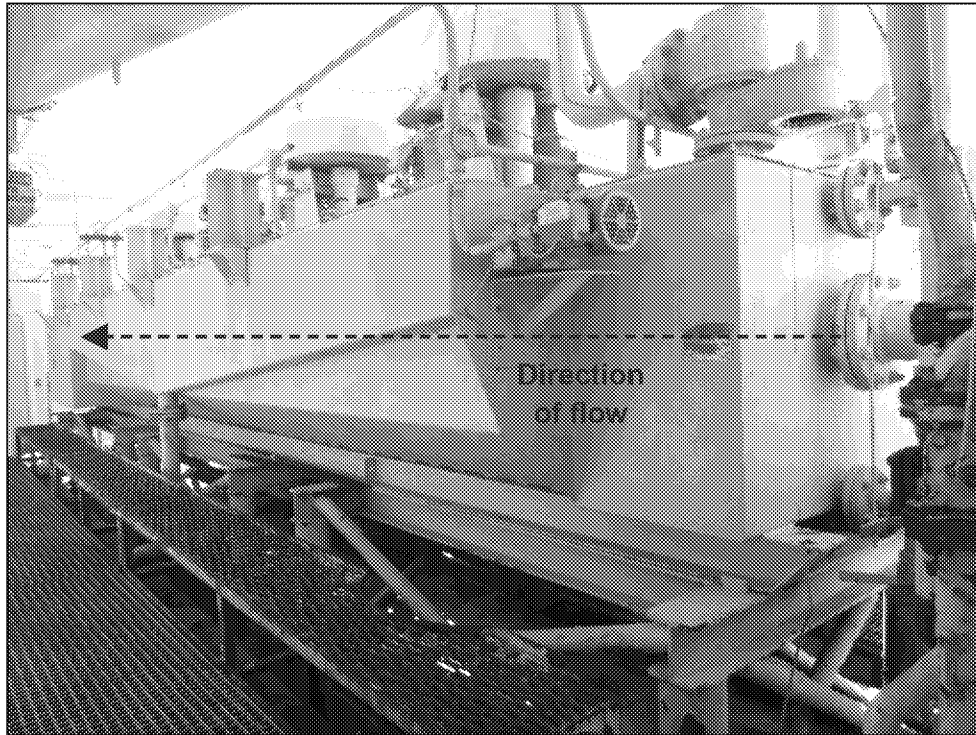
Photograph 5. View of one of two mechanical WEMCO oil and water separators used at the platform.

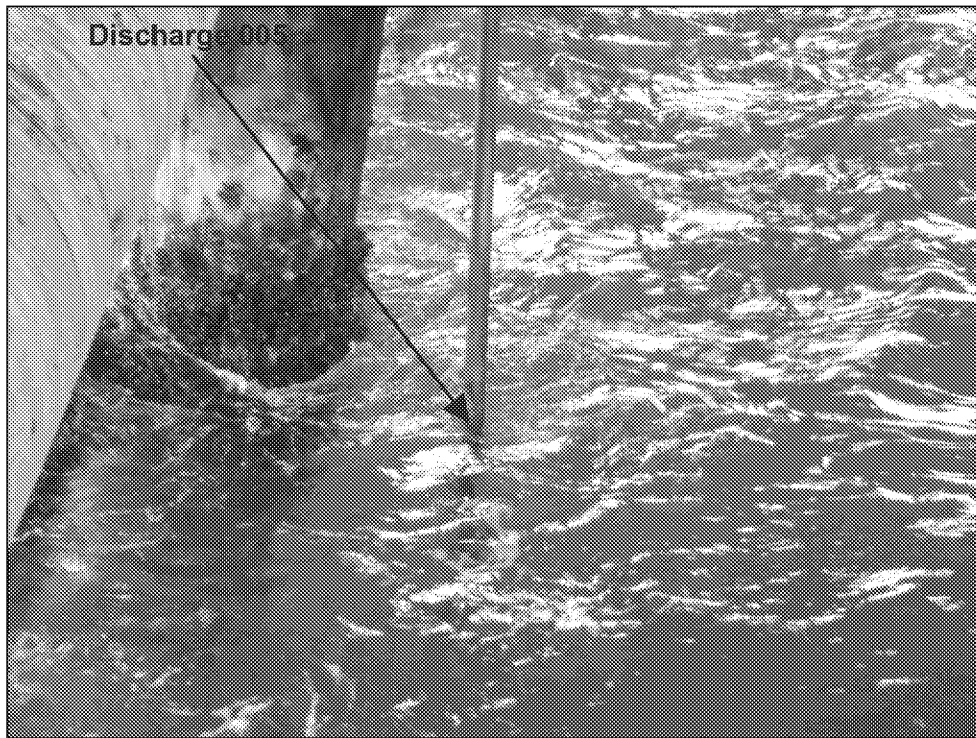
Photograph 7. View of domestic and sanitary wastes discharge point (Discharge 005) to the Pacific Ocean.

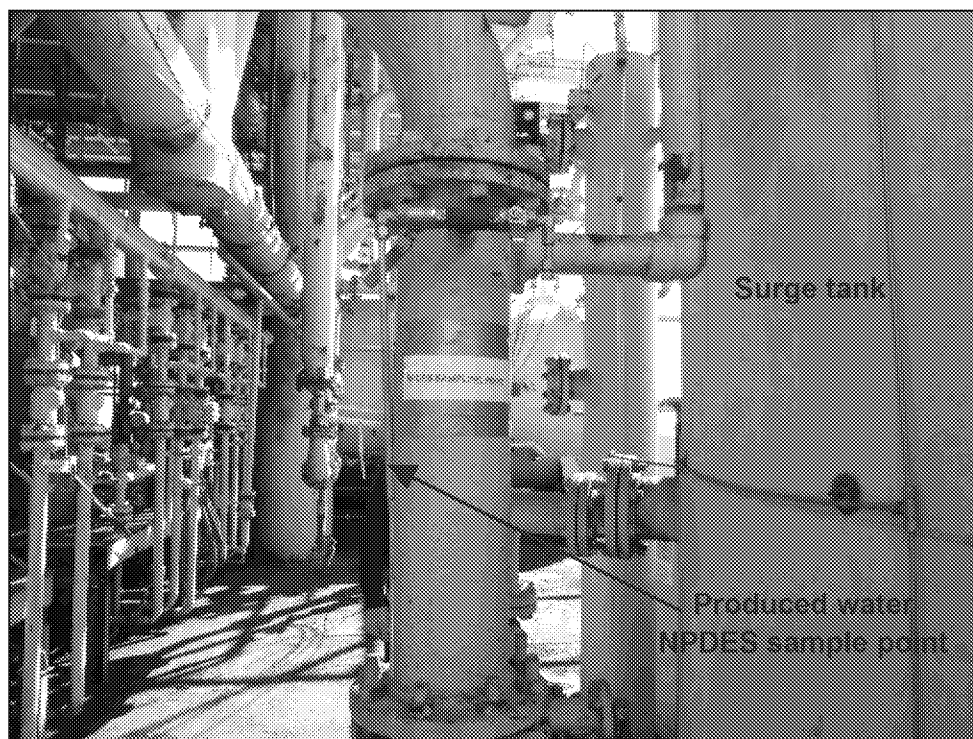
Photograph 10. View of produced water (Discharge 002) NPDES sampling point located off of the discharge pipe from the surge tank.

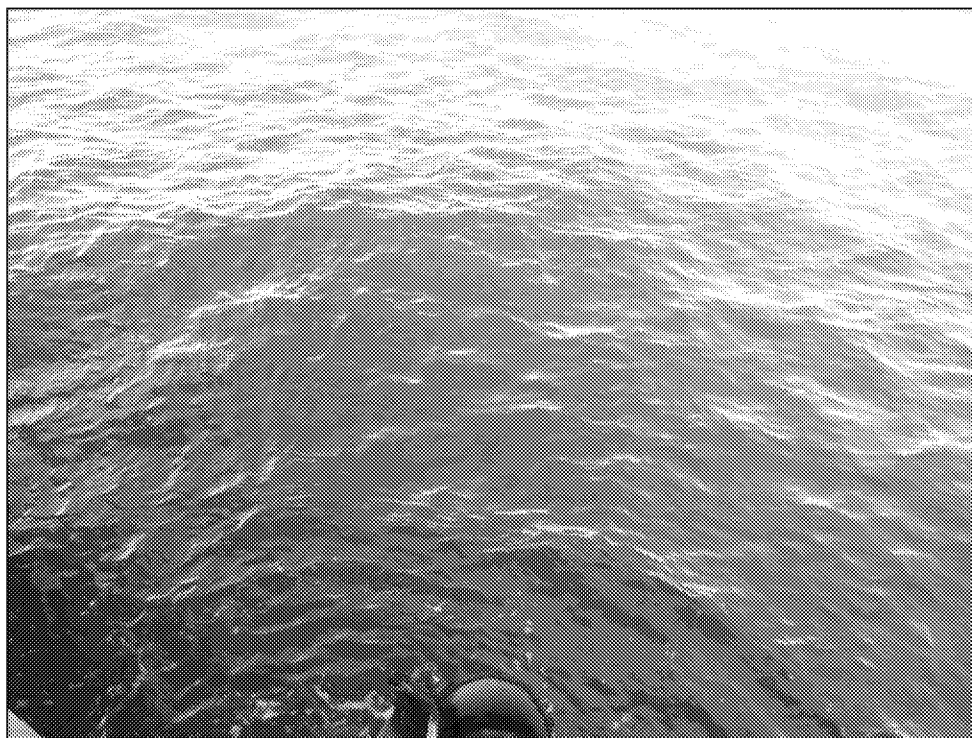
Photograph 11. View of the receiving water (Pacific Ocean) within the vicinity of platform Hillhouse at the time of the inspection.

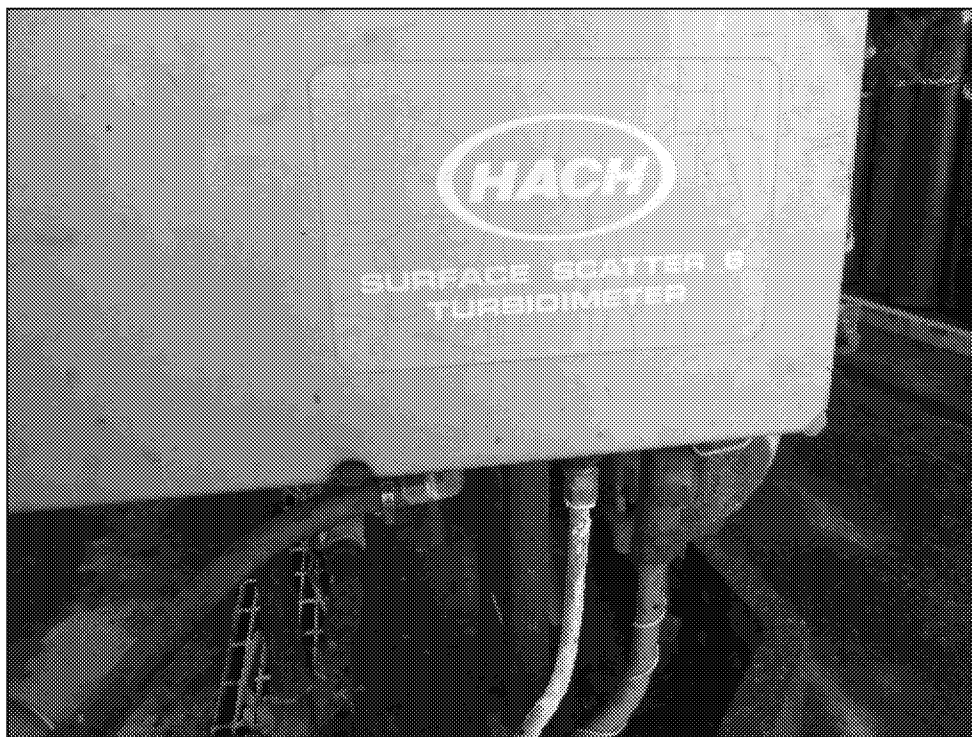
Photograph 12. View of continuous inline turbidity measurement device, a HACH Surface Scatter® 6 sc turbidimeter. The Discharger uses this to comply with Part II.G.6, On-Line Oil and Grease Monitors, of the Permit.

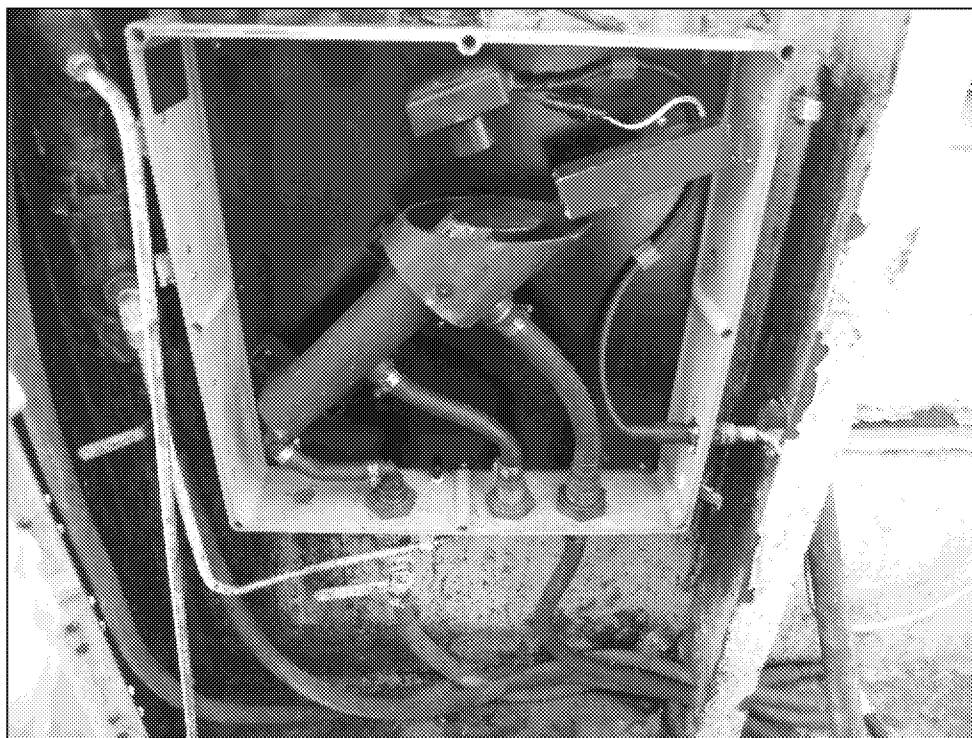
Photograph 13. Close-up view of continuous inline turbidity measurement device, shown in Photograph 12.

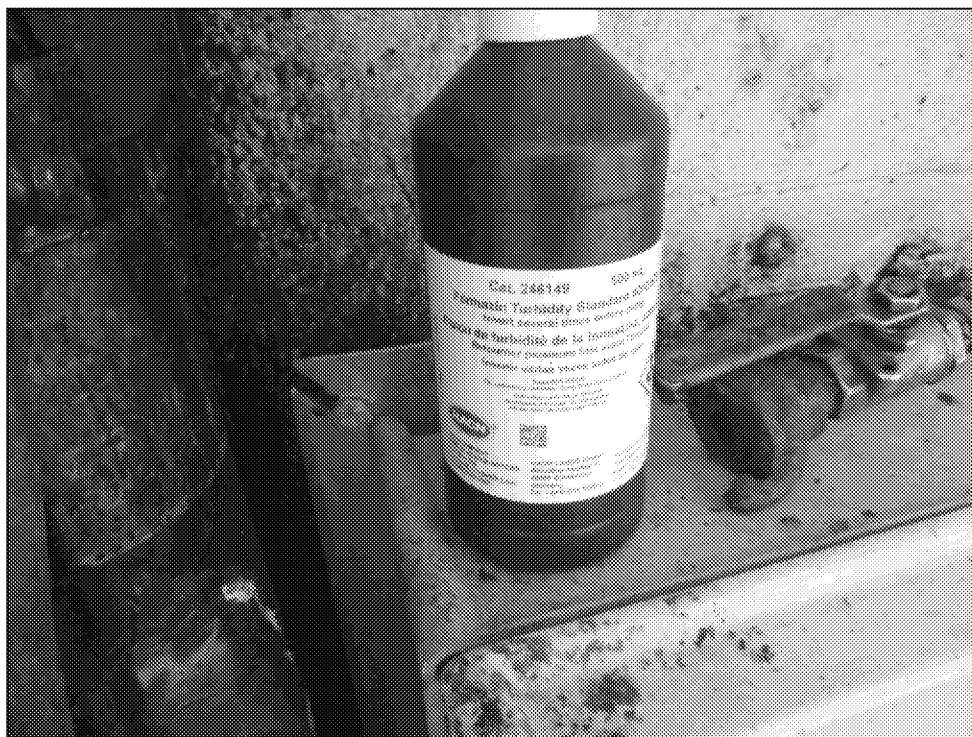
Photograph 14. View of a 500 mL bottle of 4,000 NTU formazin turbidity standard solution utilized in calibrating the inline turbidimeter via cylinder method.
